Ministry of Economic Affairs and Communications

Final Report  
Aircraft Accident Investigation

Piper PA-46 500TP, OE-KDM  
Tartu-Ülenurme, 24.11.2006.a.

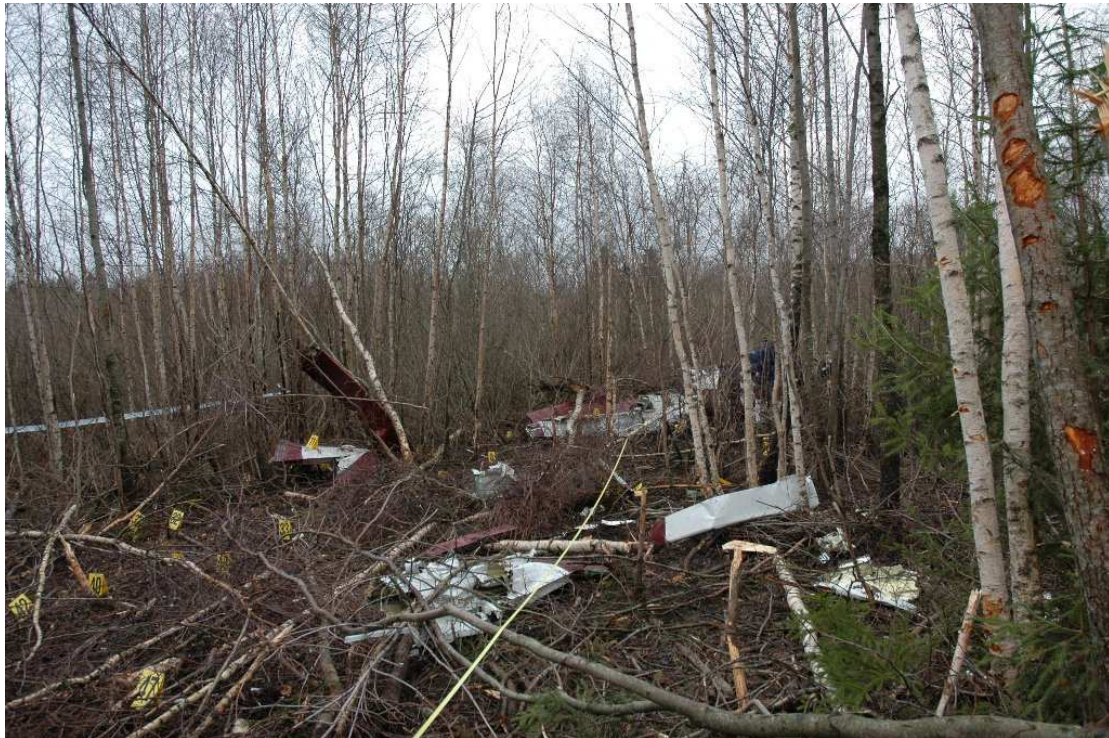
Picture 2. Impact site

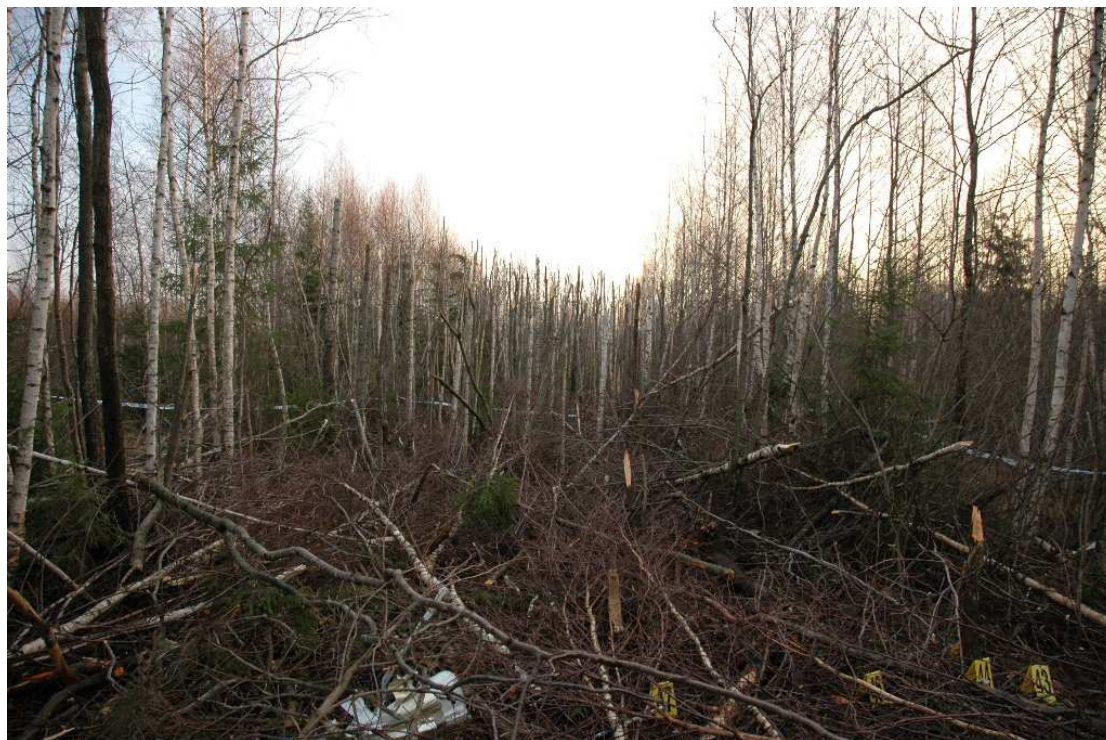
The impact area covers 140 m alongside the flight path of the aircraft. The area is covered with young treed with diameter up to 20 cm and height up to 20 m. The first tree with broken top at 16.5 m AGL was found 140 m before the impact with terrain. After the impact the fuselage has slipped forward ca 5 m before coming to full stop. The flight path and aircraft bank position was clearly determinable by cut off treetops.

**Picture 4. Cut treetops on the accident site. View from the west.**

The clearly visible flight path thru the treetops indicates the left bank ca 10-12°. Based on distance and broken treetops height the calculated impact angle was 6.8°. In the cutoff plane there is no separate mark of horizontal stabilizer which is indicative to neutral or negative pitch angle. This is coherent with the tree marks on the leading edge of the wings.

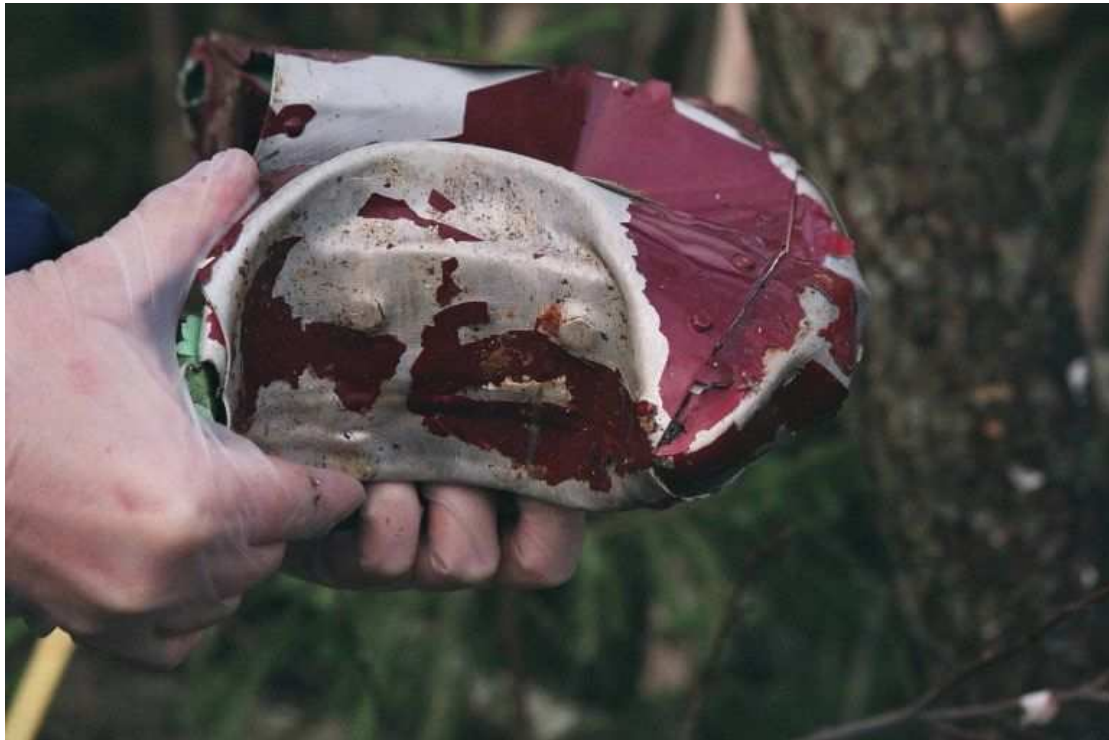
Parts of fuselage and surfaces were found alongside the impact area. Along the final portion of flight path copped wood characteristic to propeller contact was found. On the lading edges of the wings and horizontal stabilizers the impressions characteristic to the tree trunks were clearly visible.

**Picture 5. Tree impression mark**

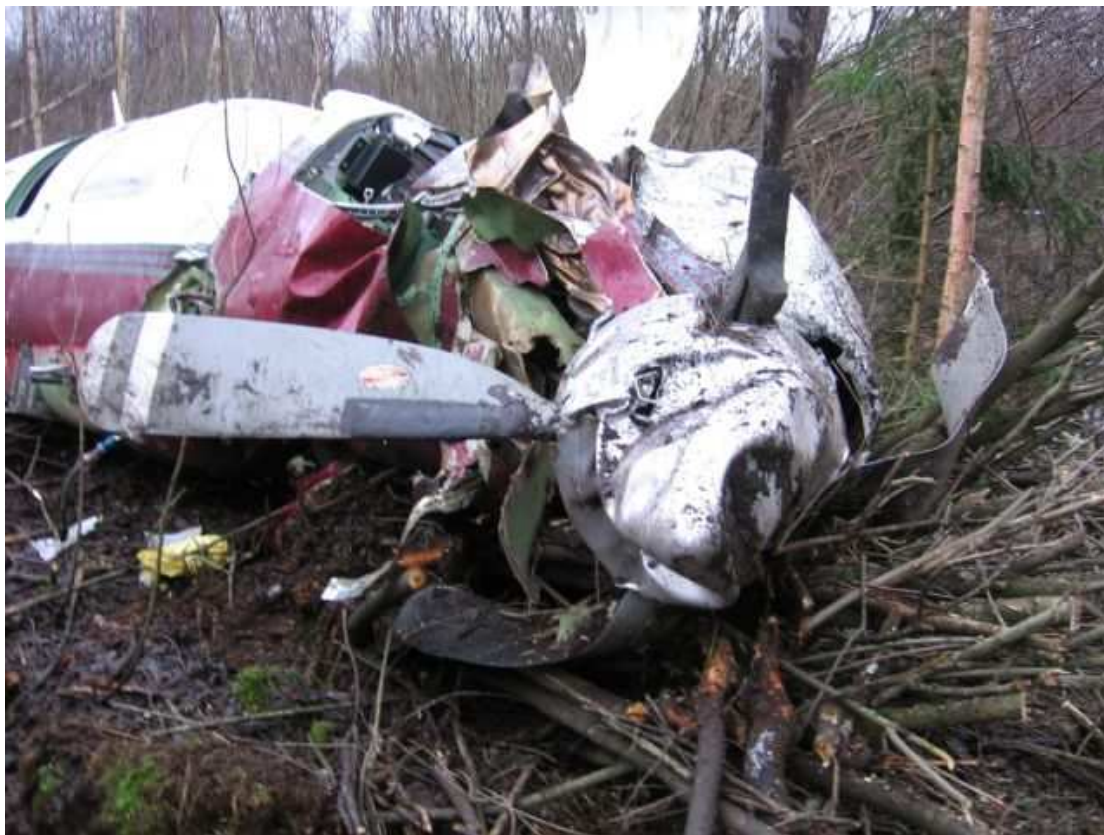
Propeller blades were in different pitch position and bent

**Picture 6. Propeller on the accident site**

Propeller disassembly report states that propeller had power on during the impact with trees. The propeller was not feathered during the impact. It was impossible to determine the amount of power during the impact.

The examination of the propeller at the manufacturer's plant established that the propeller had no signs of failure or malfunction before the impact. It was not feathered during the contact with trees and it was rotating with power on.

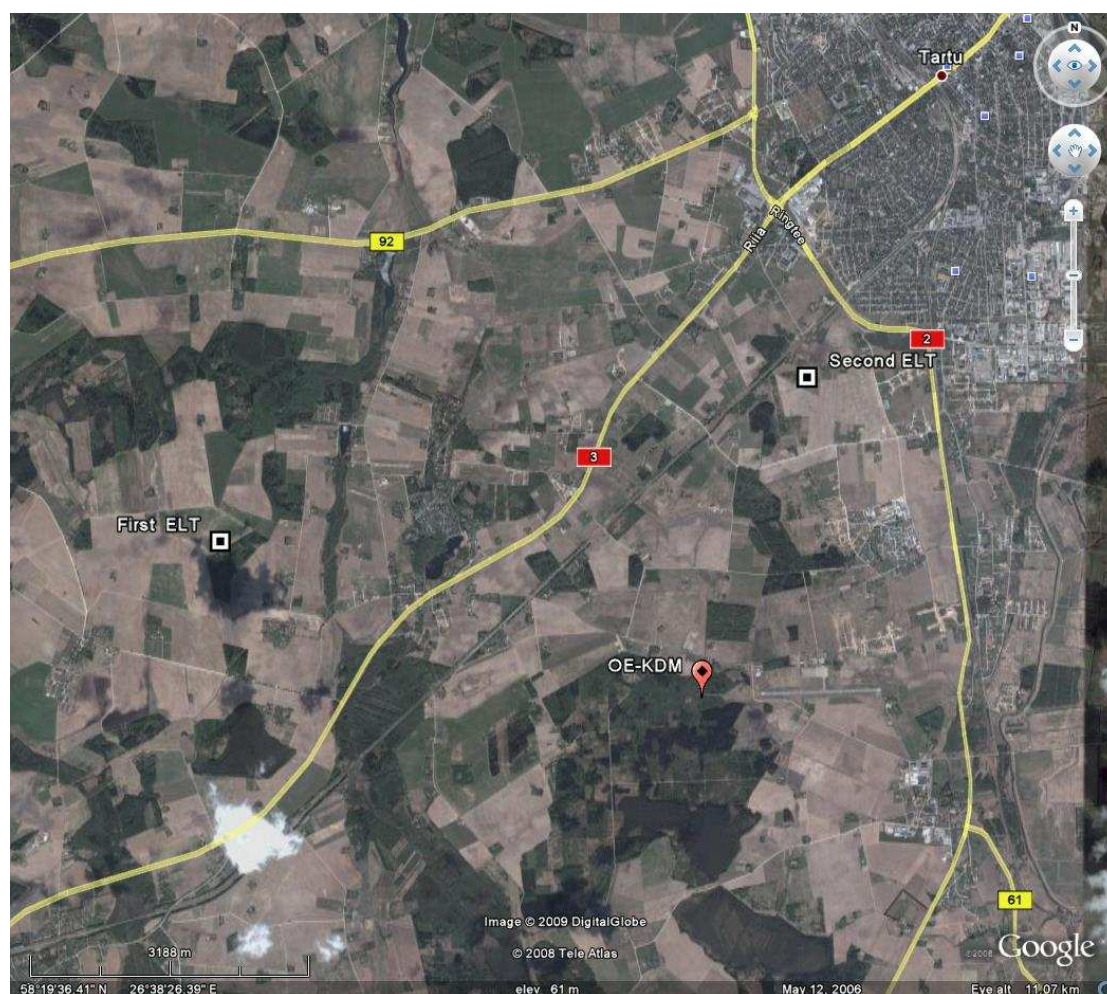
The MRCC resolved the ELT signal position at 15:30 and 15:54. Calculated positions were 3.1 and 2.05 NM off the true position respectively.

Picture 7. Resolved ELT signal positions
